Analysis of the Accident with the Platform P-36

- Report of the ANP / DPC Commission of Investigation -

July / 2001

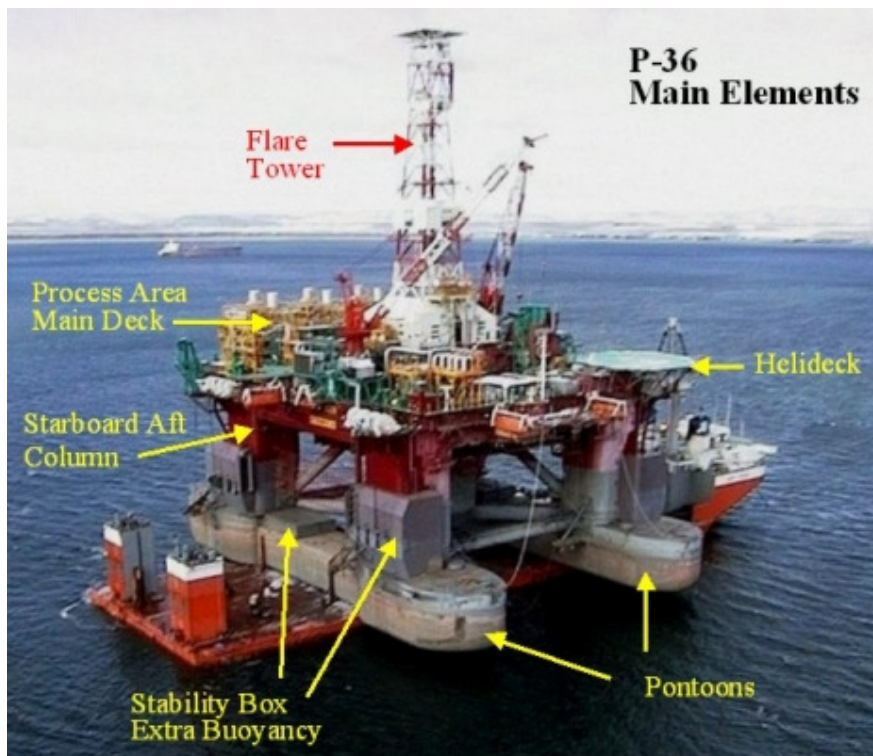
Platform P-36

A view of the platform is shown in Appendix 1, where some components related with the accident are highlighted.

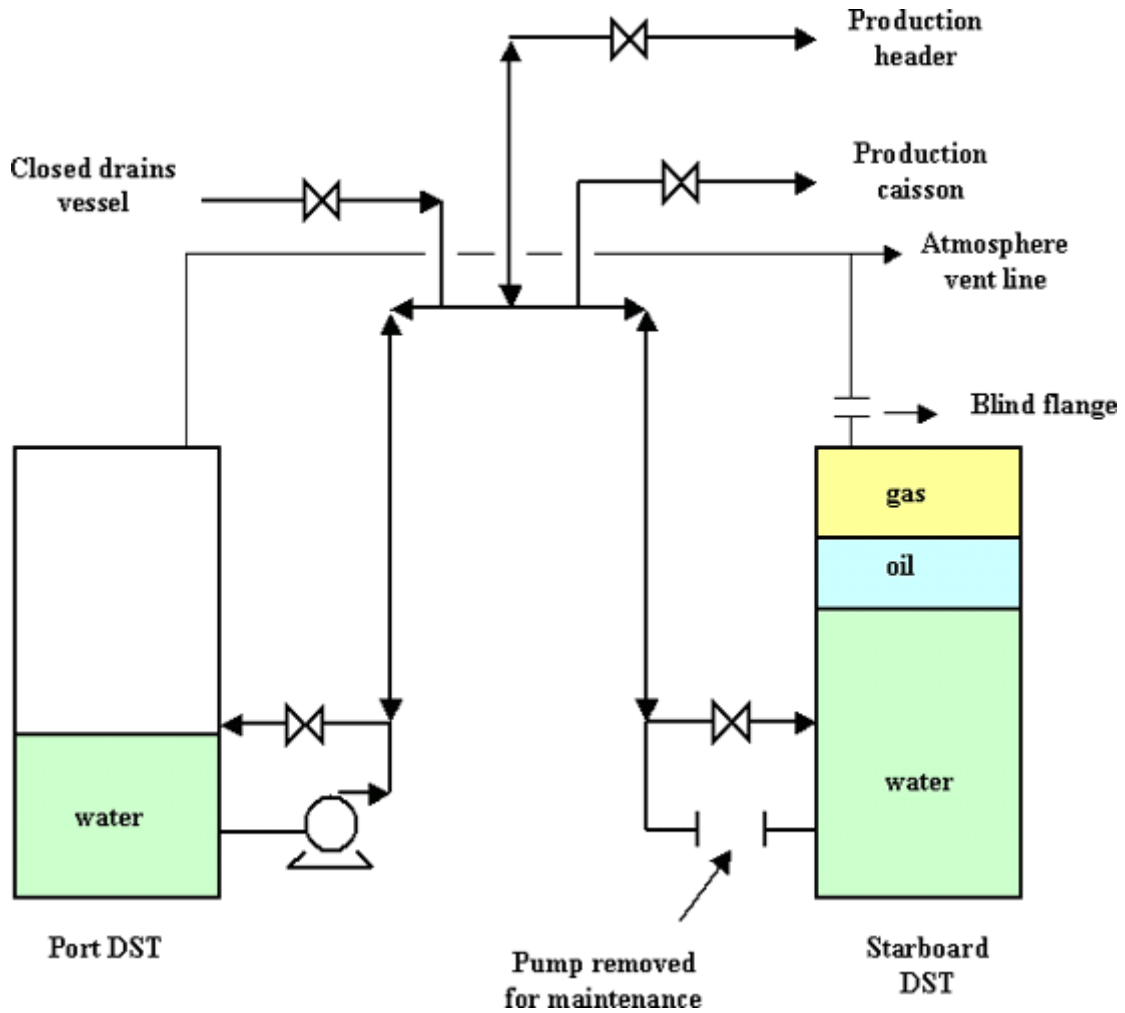
Appendix 4b - Process Flow Diagram of the Drains Storage Tanks at the Time of the First Explosion

The drainage pump of the aft starboard drains storage tank was removed for repairs on February 10, when a considerable part of the tank's capacity was occupied by contaminated water, and it was not put back into operation. Subsequently the vent line of this tank was sealed with a blind flange to avoid water entering the tank from the open drain vessel due to the blockage of its draining, as can be seen in Appendix 4b and Appendix 9.

The intake valve of the starboard tank allowed the passage of fluids into the tank, presumably because it was partially open or damaged. Consequently, since the tank vent line was blocked, as described above, continuous pressurization occurred in the tank as a result of incoming oil and gas from the production header.

An illustration of this scenario can be observed in Appendix 4.b.

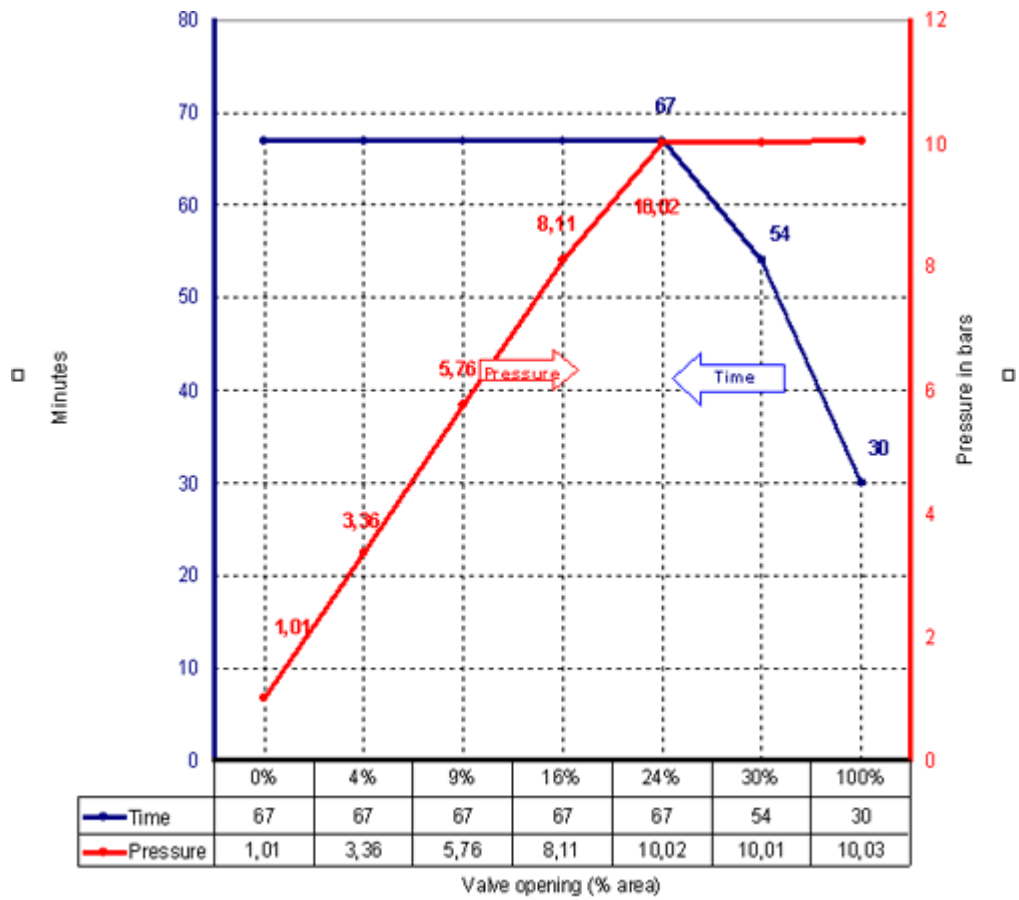
Appendix 5 - Time elapsed and pressure in the tank versus opening of the valve

The aft starboard drains storage tank was pressurized during 121 minutes until it reached a pressure of around 10 bar, receiving approximately 13 cubic meters of oil, 1460 cubic meters of gas and 64 cubic meters of water, expressed at basic pressure and temperature conditions. These results were obtained from a mathematical simulation performed by ANP, considering an opening of the intake valve of 24% of its area to allow the tank to reach the above-mentioned pressure in 67 minutes after start-up of the port tank drainage pump, as can be seen in Appendix 5.

At 12:22 a.m. on March 15, upon reaching a pressure of around 10 bar, described by the Petrobras technical team as the failure pressure, the tank ruptured, releasing water, oil and gas to the inside of the column. The increase of the internal volume of the tank as a result of mechanical strain before failure was not taken into account.

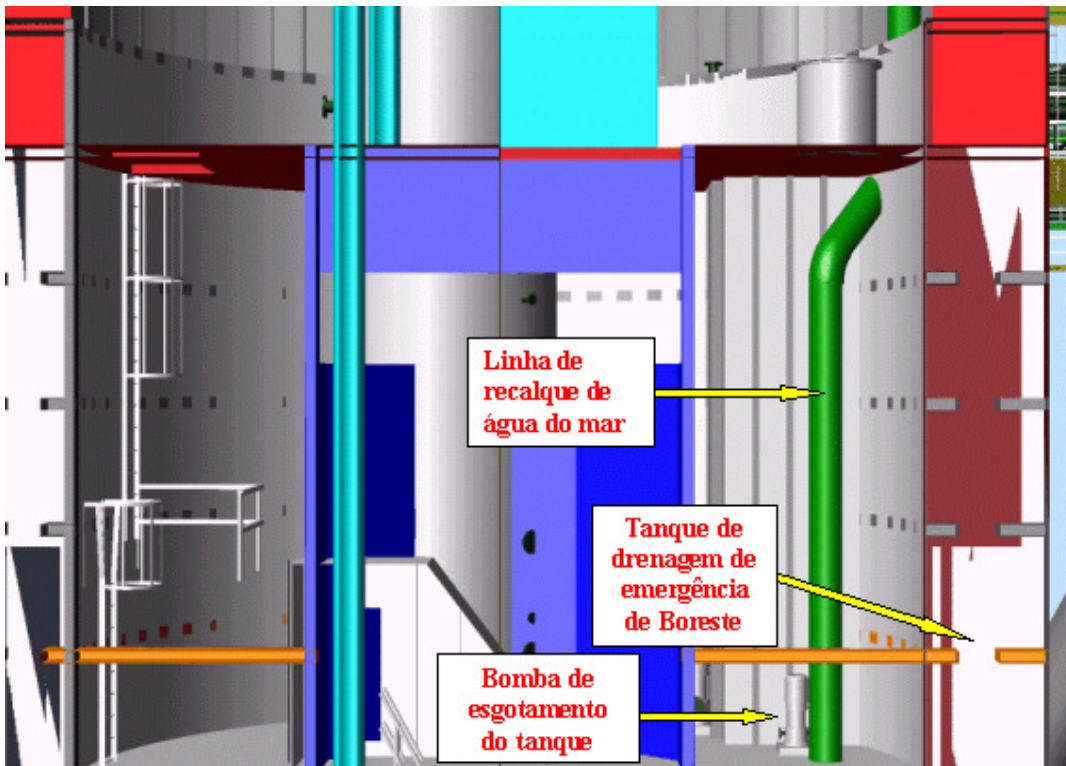
Appendix 9 - Fourth level of the Aft Starboard Column

The collapse of the tank structure caused the transfer of the fluids inside it to the fourth level compartment, in addition to the rupture of the 18-inch saltwater pipe passing alongside it, beginning the flooding of the column. As a result the main fire ring line was depressurized, leading to the automatic shutdown of the process plant. The tank vent lines located below the third level of the column also ruptured.
