Safety Alert 003 - ANP/SSM

Flare tower failure due to resonance effect

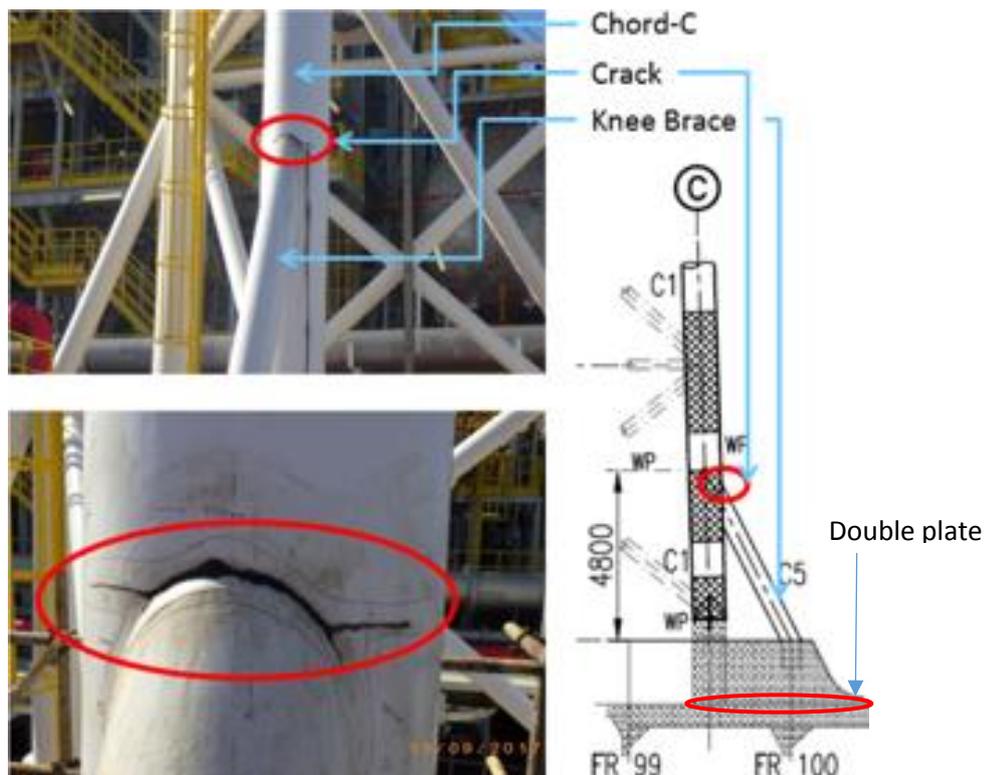
The incident that motivated this alert occurred in September 2017 in a floating, production, storage and offloading unit (FPSO), after around one year of operation. An excessive flare tower vibration led to a major crack, circa 950 mm length, in the bracing connected to the forward leg at the flare foundation on the hull, leading to the complete shutdown and evacuation of non-essential personnel.

This flare tower is a fixed stack supported by three main elements, which are reinforced at the base by knee braces. The crack occurred at the connection weld of the knee brace to the leg, as well as at doubling plate connection of the flare legs on the hull deck, as showed in the picture:

ANP recommends ensuring during engineering phase of FPSO units that all structural natural frequencies are separated, including hull natural frequency for all draft condition to avoid significant dynamic amplification and fatigue sensitivity.

Additionally, it is recommended that all FPSO units in operation are checked to ensure that flare tower natural frequency is sufficiently away from the hull natural frequency for all cargo conditions. The identified risks shall be managed in accordance with operational safety management practices.

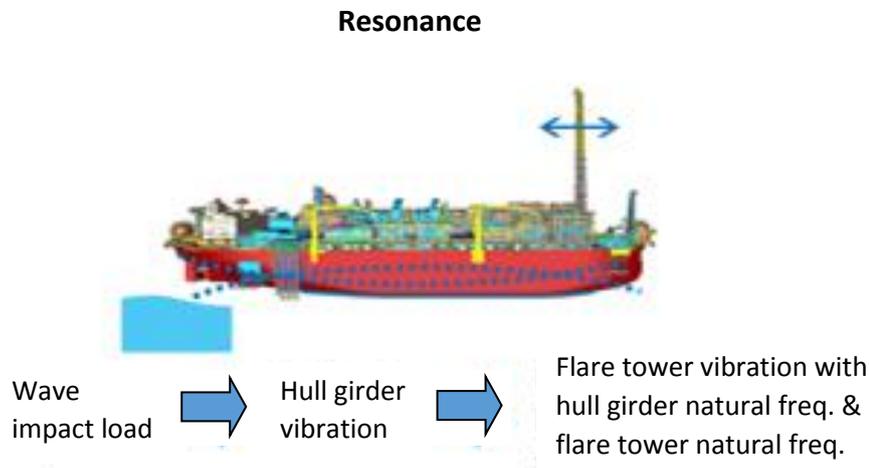
- Resonance effect due to hull girder natural frequency coinciding with the flare natural frequency at a specific draft;
- Inadequate engineering design (knee brace location, doubling plate);
- Excessive stress concentration;
- Slamming inducing whipping and excitation of the flare tower natural frequency (resonance).

Therefore, significant amplification and excessive flare movements were observed leading to cracks occurring at the weakest part of the structure:

The Root Cause Analysis performed by the operator confirmed that the severe conditions and dynamic amplification due to nonlinear response (whipping effect) would lead to a flare tower structure reduced fatigue life down to couple of months.
